**SELECTIVE WEAKENING AND POST-
TENSIONING FOR THE SEISMIC RETROFIT
OF NON-DUCTILE RC FRAMES**

WENG YUEN, KAM

NOV 2010

A thesis submitted in partial fulfilment of the requirements
for the Degree of
Doctor of Philosophy in Civil Engineering

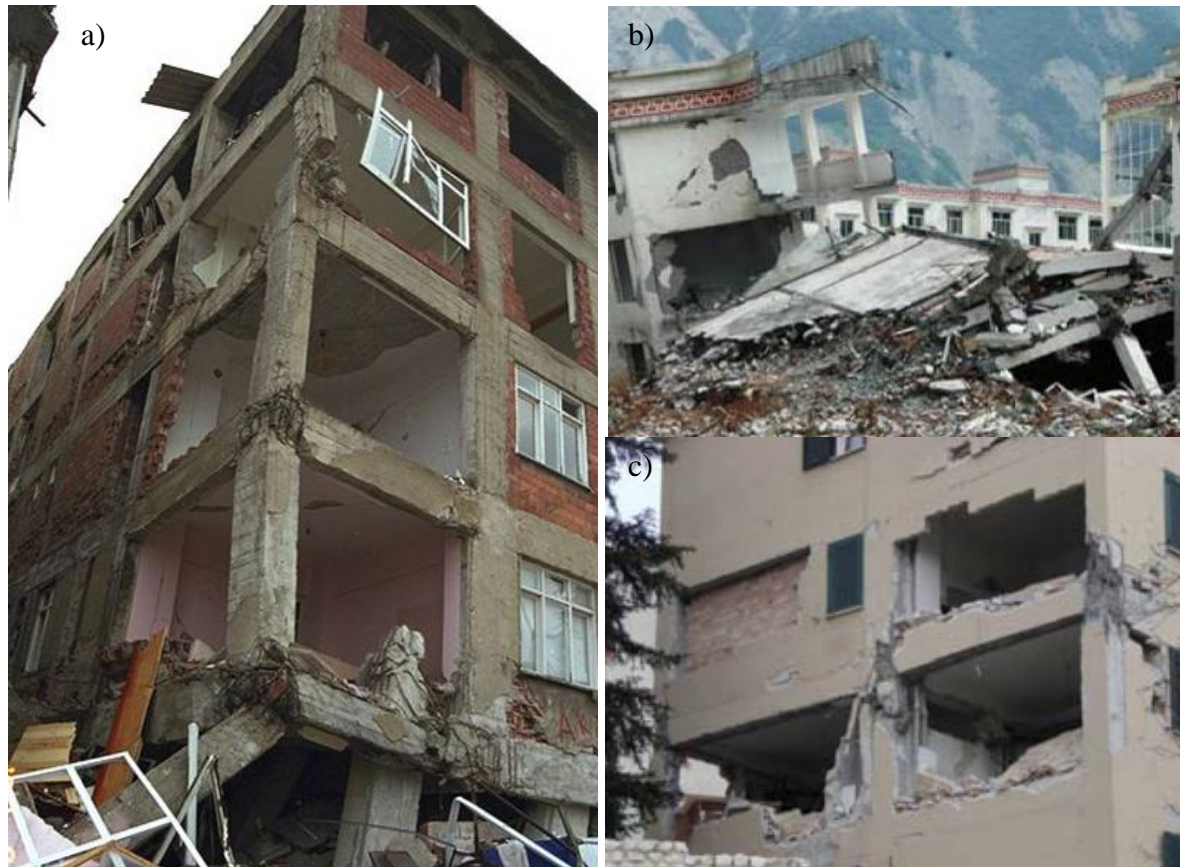
Figure 2.14: a) Corner non-ductile RC beam-column joint failures, Kocaeli/Izmit 1999 earthquake (photo credit: Halil Sezen, NISEE collection [156]; b) Collapse of RC frame school building in Yingxiu city, Wenchuan 2008 earthquake (Photo taken from:[239]); c) Damaged beam-column joints at moderate L'Aquila Italy earthquake (photo credit: Dr Anna Brignola).

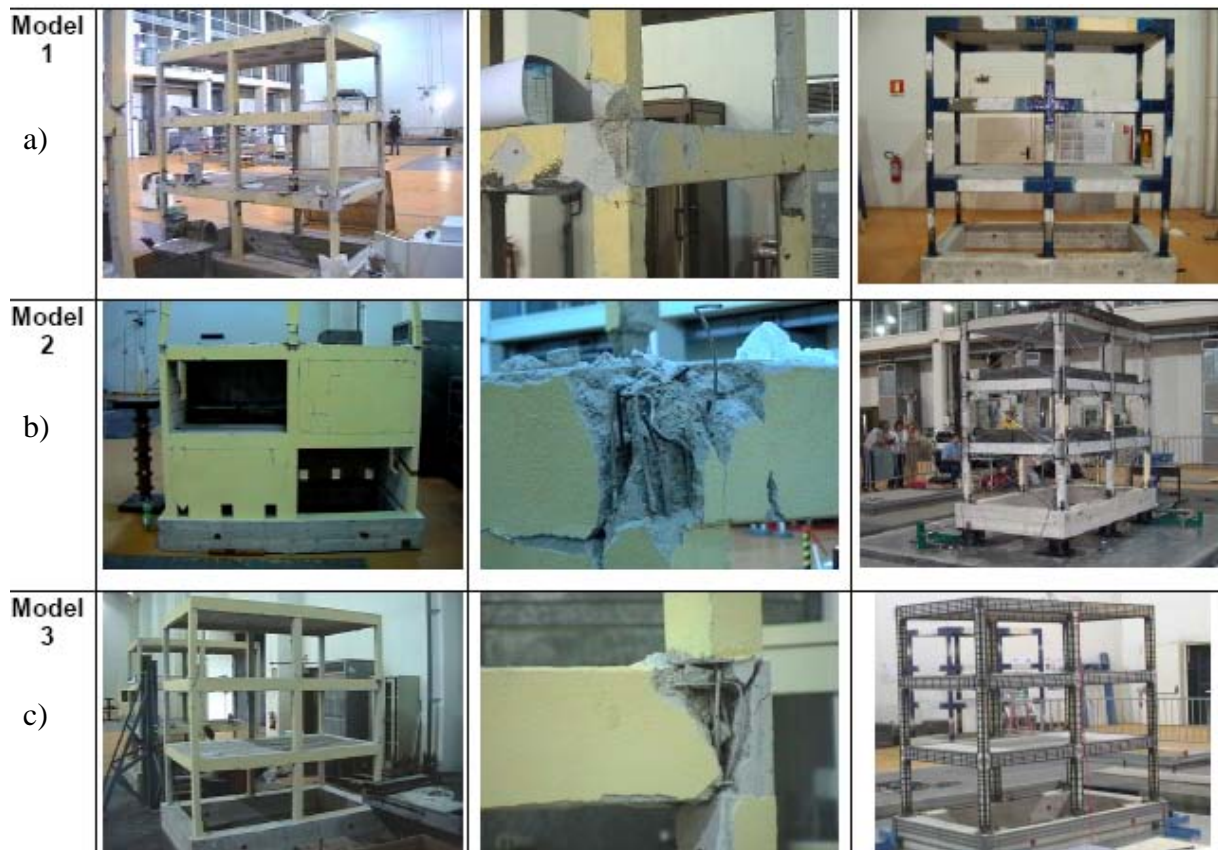
Figure 3.13: Different retrofit strategies and techniques for non-ductile RC frames: a) Model 1: Local strengthening using FRP jacketing; b) Model 2: Base isolation retrofit; c) Model 3: prestressed steel bracket confinement and strengthening solution [45].

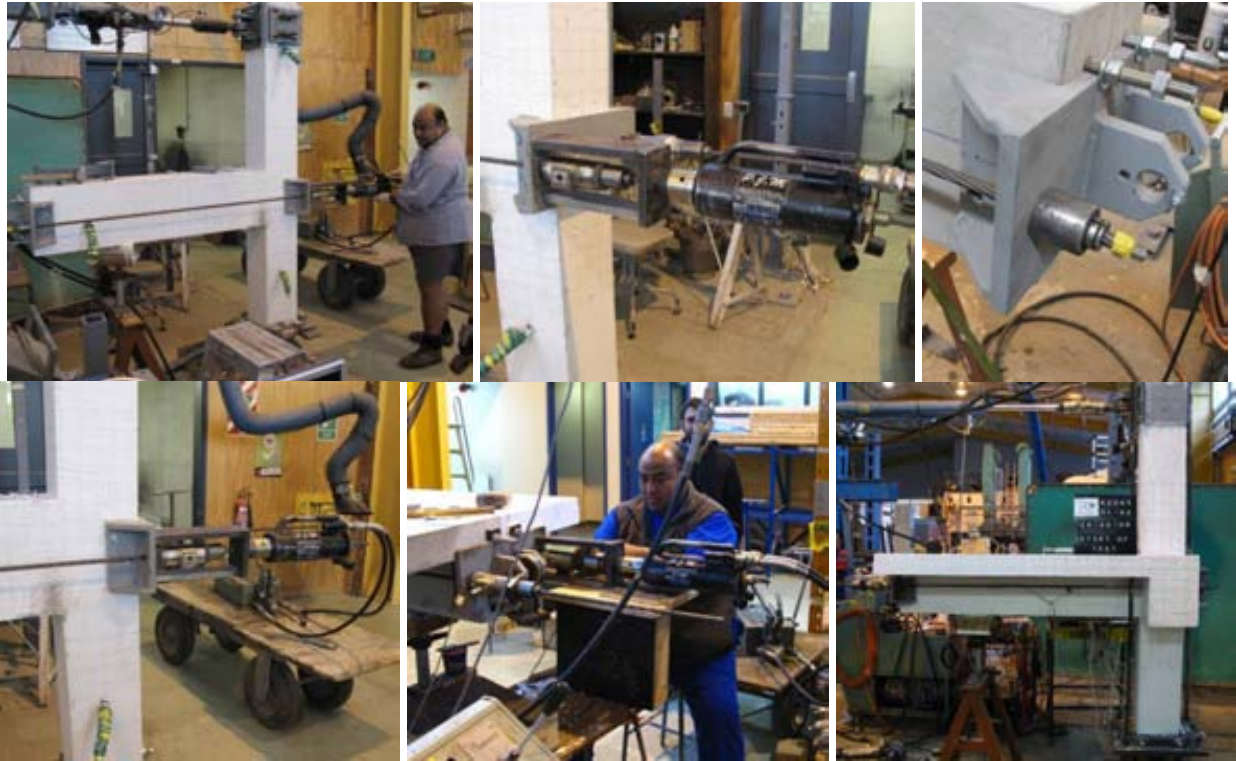
Figure 4.9: External post-tensioning retrofit intervention using monostrand hand-pump hydraulic jack on external steel plate anchorages.

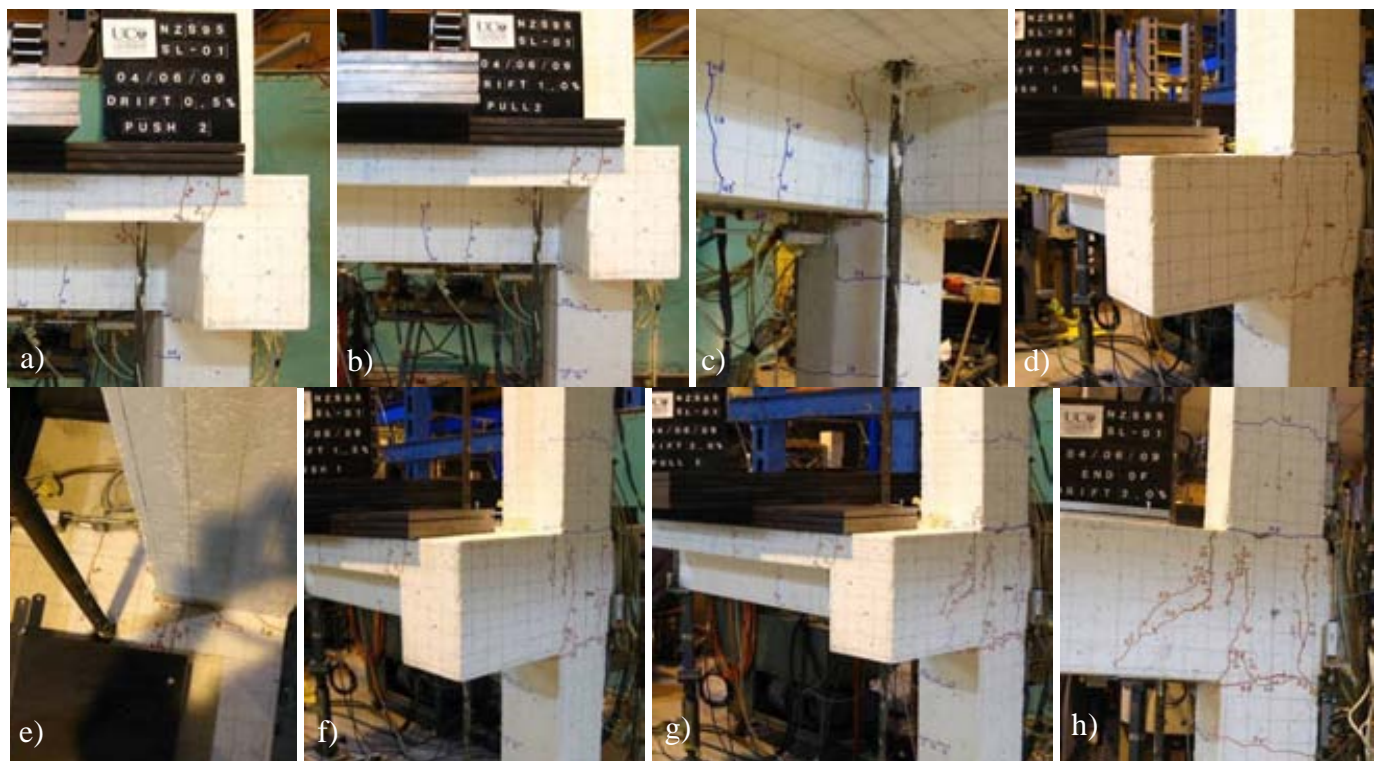
Figure 8.3: Observed cracking pattern of SL-O1: TOP: a) 2nd Push cycle of the -0.5% drift; and b-c) 2nd Pull cycle of the +1.0% drift and d) 2nd Push cycle of the -1.0% drift. BOTTOM: e) 2nd Push cycle of the -1.0% drift; f) 1st Push cycle of the -1.5% drift; and g) 2nd Pull cycle of the +2.0% drift; and h) Residual after Pull-Push cycles of the $\pm 2.0\%$ drift.
